## Strength Assessment and Restoration of RC Structures by Structural Health Monitoring Techniques

### 3.1. Tests Conducted on Water Tank

**Tests conducted on Ration Shop Building in Kenjanur**

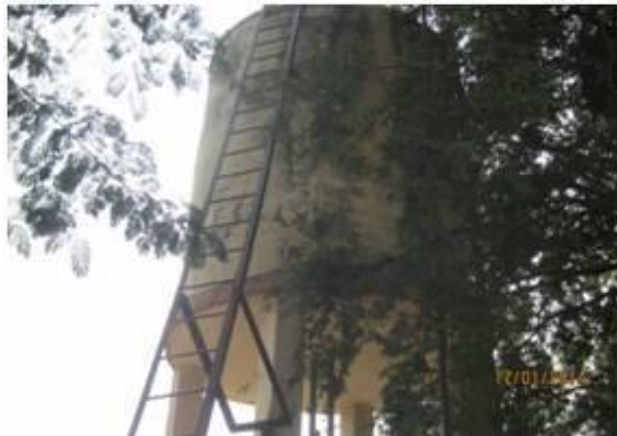
Fig.3.1 Image of the Water Tank

The Water tank was constructed in the year 1985. The capacity of Water tank was 15000 litres. The water tank is rested on four Columns, where columns are connected by Braces of size 250mmx250mm.

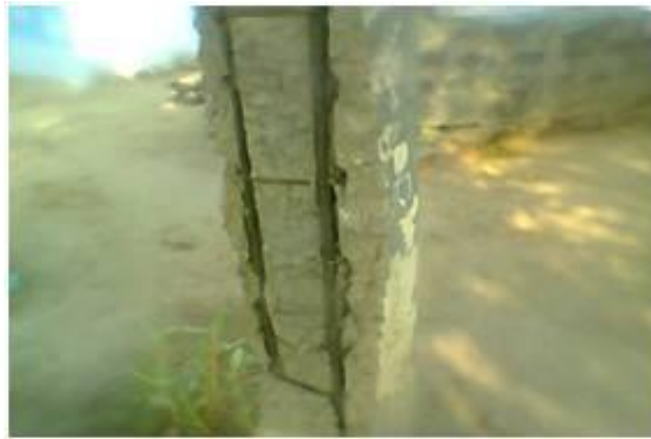
Fig.3.2 Image of Spalled Column of the Water Tank

After carrying out the NDT tests in the selected project areas we found that the water tank at Sunnambukarayur was in poor condition. Its structural members were corroded to 90% it becomes unfit for use, while the Ration shop building at Kenjanur and Staff quarters at Bhavanisagar are in good condition but some minor defects had been mitigated. The damages located in the Ration shop and staff quarters can be rectified by adopting suitable repairing

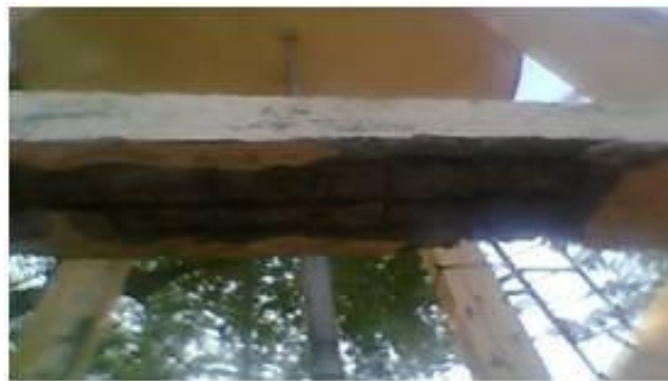
Fig.3.3 Image of the Spalled Brace of the Water Tank

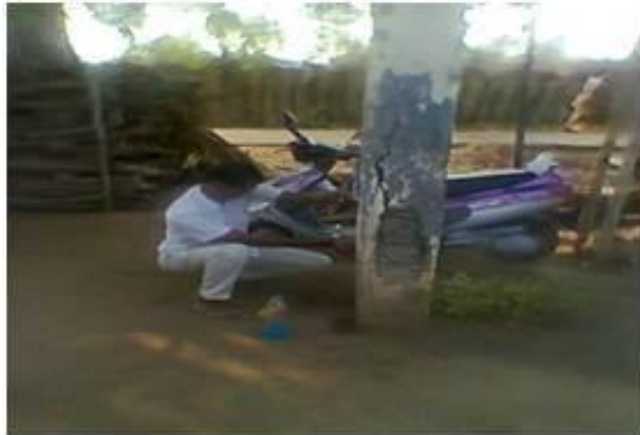
Fig.3.4 Half Cell Potential Difference Test being conducted on Column of the Water Tank

Member	Point 1 (in mV)	Point 2 (in mV)	Point 3 (in mV)	Average (in mV)	Probability of Corrosion
Column 1	-460	-420	-397	-426	90%
Column 2	-405	-426	-415	-415	90%
Column 3	-396	-411	-387	-398	90%
Column 4	-368	-391	-361	-367	90%

Member	Point 1 (in mV)	Point 2 (in mV)	Average (in mV)	Probability of Corrosion
Brace 1	-370	-352	-361	90%
Brace 2	-341	-384	-363	90%
Brace 3	-297	-325	-311	Uncertain
Brace 4	-347	-381	-364	90%

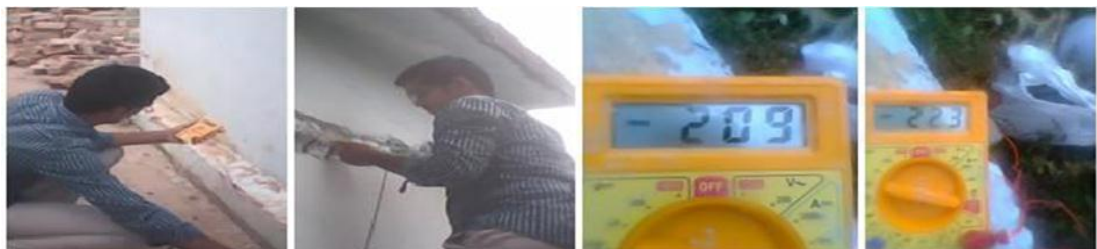
**Fig 4.1 Half Cell Potential Difference test being conducted on the Ration Shop building**

Member Plinth Beam	Half Cell potential Difference between Reinforcement and Concrete in mV
Point 1	-223
Point 2	-209
Point 3	-159
Point 4	-169
Point 5	-185
Point 6	-168
Point 7	-207
Point 8	-185
Point 9	-221
Average	-192

Member-Main Roof	Half Cell potential Difference between Reinforcement and Concrete in mV
Point 1	-271
Point 2	-307
Point 3	-289
Point 4	-321
Point 5	-332
Point 6	-296
Point 7	-281
Point 8	-312
Point 9	-290
Point 10	-312
Point 11	-261
Point 12	293
Average	-298
